KEIZER MERCURY ER  
054 0548 110

**SUBJECT:** Action Memorandum for the Keizer Mercury Emergency Response Site,  
Keizer, Marion County, Oregon

KEIZER MERCURY SPILL ACTION  
MEMORANDUM  
Keizer, Oregon

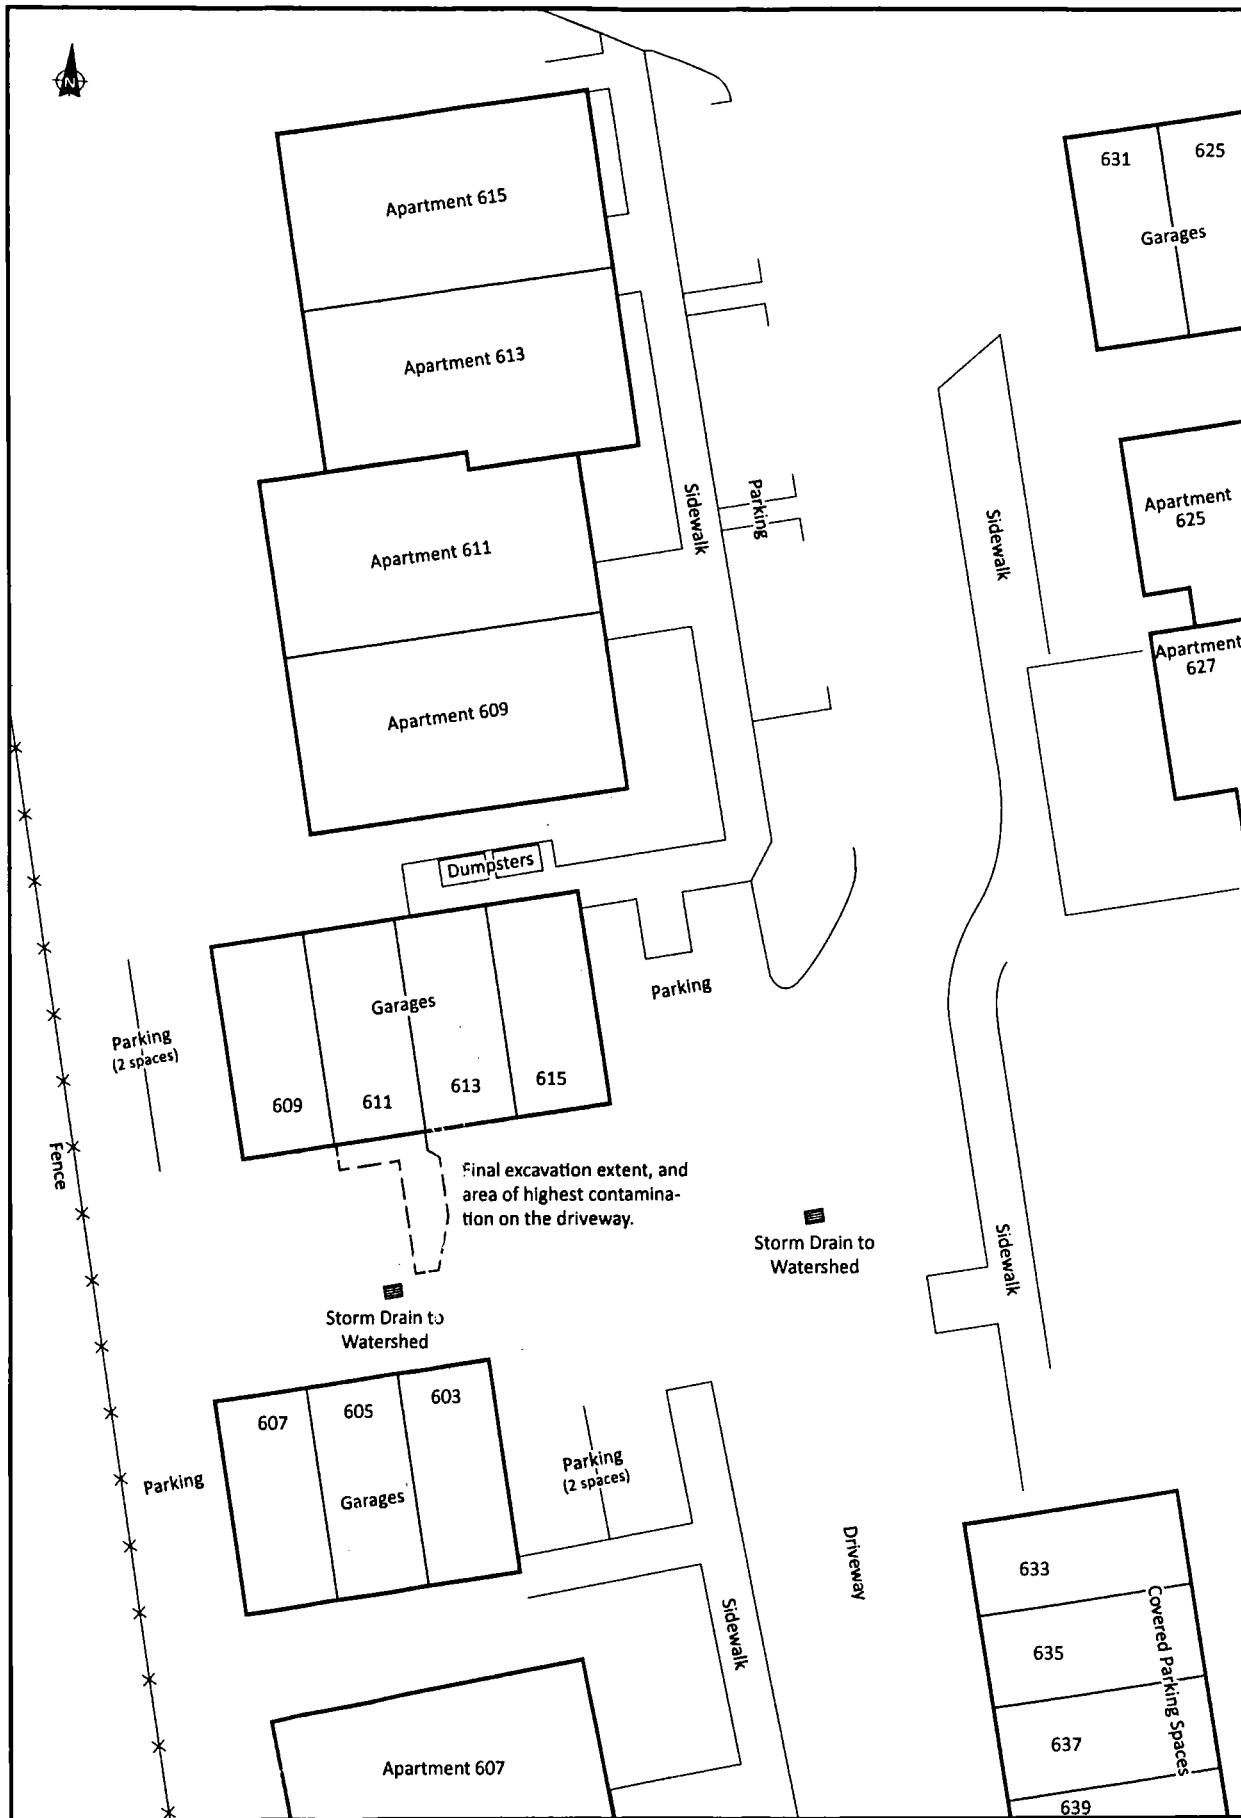
Figure 2  
SITE MAP

**City of Keizer storm water drain** – A storm water drain maintained by the City of Keizer was located in the middle of the driveway/parking area; see Figure 2 for locations of storm drains in relation to spill site. A trail of mercury beads led from garage unit 611, across the asphalt driveway/parking lot, down

slope to the vicinity of the storm water drain. Although mercury beads were not visible in the storm drain, START collected a sample of the sediment from the storm drain and screened the sample with the Lumex. The mercury vapor concentration from the sediment was as high as 47,000 ng/m<sup>3</sup> in the drain nearest garage unit 611. START performed similar sampling and analysis of the sediment from the next storm drain downgradient (approximately 45 feet downgradient) and mercury vapor concentrations from that sample were 120 ng/m<sup>3</sup>, indicating that the mercury had not migrated laterally through the storm drain system. NRCES hand-shoveled, scraped, brushed, and vacuumed all sediment from the affected storm drain catch basin, heated the storm drain catch basin with a torch, and then used a ventilation fan to thoroughly volatilize any residual mercury and dry out the storm drain system. On August 14, 2016, mercury vapor concentrations in the storm drain detected by the Lumex were less than the ATSDR commercial re-occupancy concentration of 3,000 ng/m<sup>3</sup> and therefore no further removal activities were necessary in the storm drain system.

**Garage unit 609:** See Figure 2 for the location of the spill site in reference to the contaminated garages. Mercury beads were not observed in garage unit 609; however, mercury vapor was detected on the floor, on bicycles, and in the breathing zone up to 6,100 ng/m<sup>3</sup>. The mercury vapor detections on the tires on several bicycles and scooters appears to have been the result of cross contamination from mercury beads on the asphalt driveway. Concentrations detected from the bicycle tires ranged from 1,000 ng/m<sup>3</sup> to 4,000 ng/m<sup>3</sup>. The bicycles were placed out in the sun to promote passive mercury volatilization on August 13, 2016. On Thursday, August 18, 2016, screening with the Lumex indicated the concentrations in garage unit 609 were less than the ATSDR commercial re-occupancy concentration of 3,000 ng/m<sup>3</sup> and therefore no further removal activities were necessary in garage unit 609.

**Community Trash Bins** – Up to 22,000 ng/m<sup>3</sup> of mercury vapor was detected inside one of the community trash bins located behind the garages (see Figure 2 for location). All bags of trash were removed and screened individually with up to 43,000 ng/m<sup>3</sup> mercury vapor detected in one of the bags. Bags with mercury vapor detection of 6,000 ng/m<sup>3</sup> or higher were disposed as hazardous, while the remainder were placed back into the municipal waste stream. The interior of the trash bin was treated with sulfur powder. Lumex readings after decontamination efforts indicated a reading of 2,230 ng/m<sup>3</sup>. The OSC concluded that no further action was necessary.
